**PUBLIC FACILITIES REPORT & WQA  
RZN-2021-0018 LAKE KILBY  
SUBDIVISION 2056 LAKE  
COHOON ROAD SUFFOLK, VA**

PUBLIC FACILITIES REPORT & WQIA  
 KILBY SHORES SUBDIVISION  
 2056 LAKE COHOON ROAD  
 SUFFOLK, VA

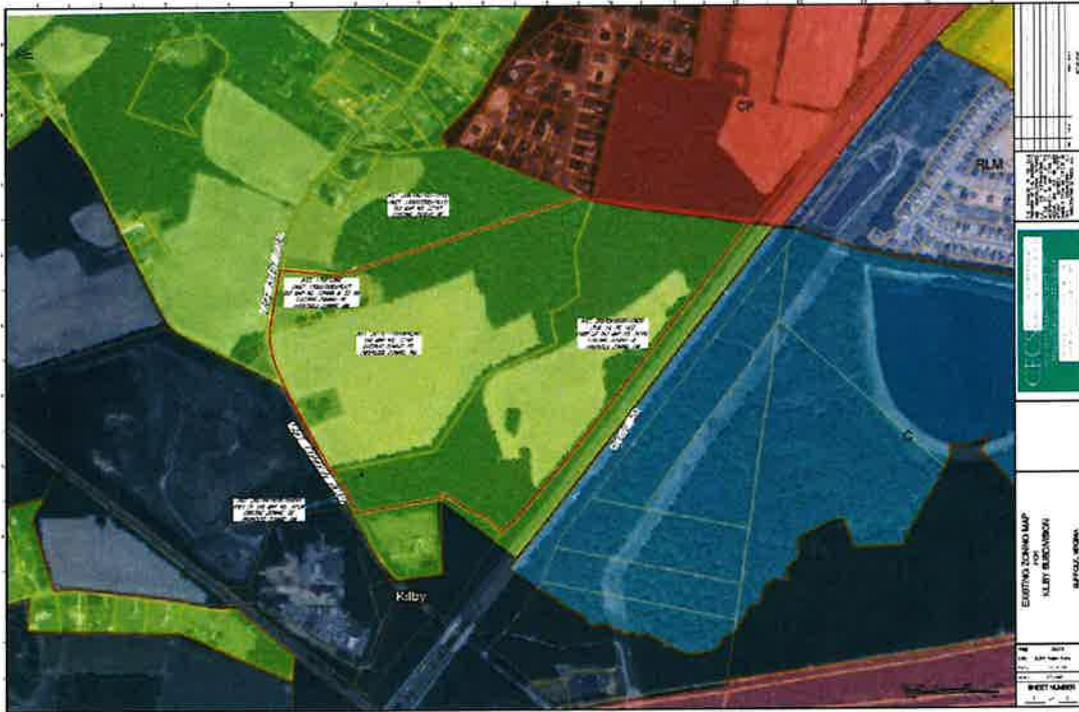
Figure 1.0- Existing Zoning Exhibit

The subject properties are identified as Tax Map Parcels 33\*48, 33\*48A, 33\*49 and 34\*26. Parcel 33 \*48 is addressed as 2600 Lake Cohoon Rd. The property is generally bounded to the east by I-58, to the west by Lake Cohoon Rd., and Lake Kilby Rd, to the south by Lake Cohoon Rd and property zoned RE. and to the north by properties zoned RL, RE, and CP. The existing parcels consists of approximately 87.58 acres. The proposed development intends to Rezone the project limits to RM to allow for the proposed single-family detached use. See Appendix A for a Rezoning Survey Exhibit. The proposed project limits are shown below in red on Figure 1.0 and has approximately 2,624 linear feet of frontage along I-58, 738 linear feet of frontage along Lake Kilby Rd. and about 950 linear feet of frontage along Lake Cohoon Rd.

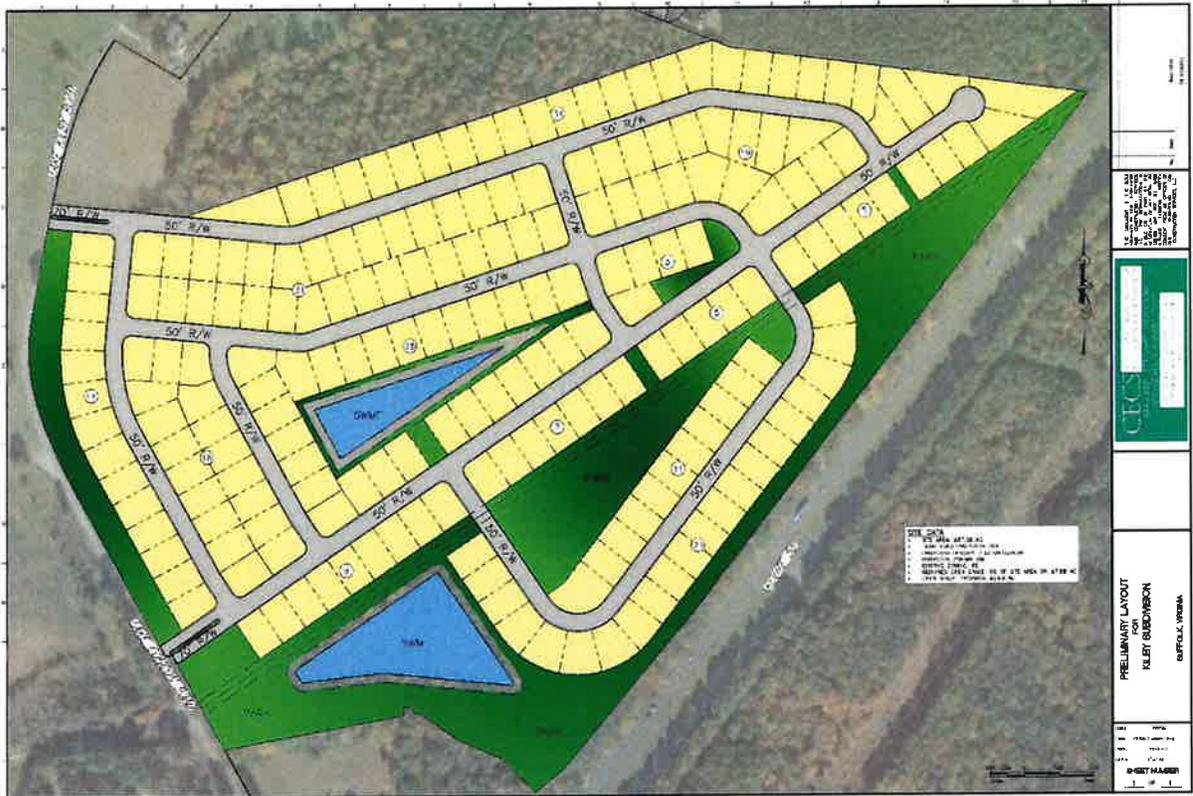
Figure 2.0 - Preliminary Concept Plan

2.1 The intent of the project is to develop the proposed property into a development that will meet the provisions set forth in the UDO for single-family detached developments. The development will consist of 204 single family units as shown below in Figure 2.0. The infrastructure improvements include parks and open space amenities, domestic water and sanitary sewer services, and storm drainage system.

Primary access to the development is proposed from Lake Cohoon Rd. and Lake Kilby Rd. as shown in Figure 2.0 below. Additional access information is provided in the Traffic Report submitted under separate cover.

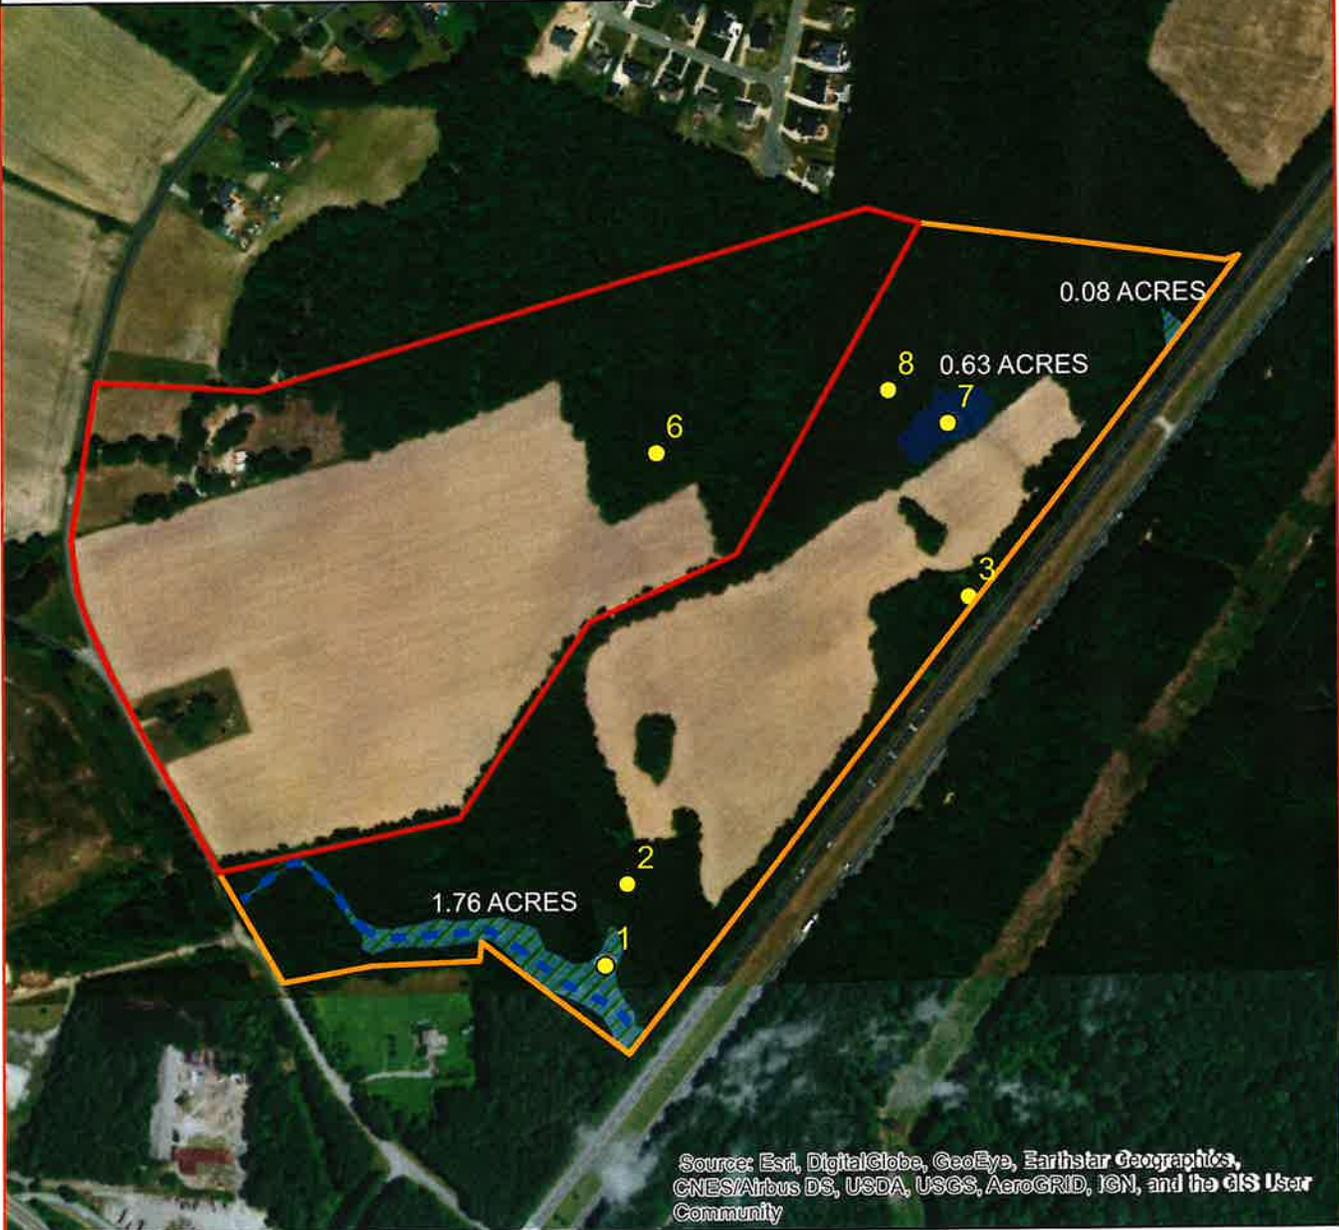
**REVISED WETLAND  
 DELINEATION EXHIBIT**

MSA has revised the wetland delineation exhibit to only show the limits of wetlands that were approved in the four parcels that remain part of the proposed development. That exhibit is attached for our record and use. A total of 2.47 acres of wetlands were identified, including 0.63 acres of isolated forested wetlands and 1.84 acres of connected forested wetlands.

- Flojo Property +/- 45.6 Acres
- Sternat Property +/- 42 Acres
- Wetland Datapoints
- - - Streams
- Connected PFO Wetlands 1.84 Acres
- Isolated PFO Wetland 0.63 Acres

- i) A total of approximately 2.35 acres of non-tidal palustrine forested (PFO) wetlands were identified within the property during the wetland delineation by MSA. Approximately 0.63 acres of isolated wetlands are proposed to be impacted by this development. The wetlands delineation Report is included in Appendix D

3. A total of approximately 2.39 acres of non-tidal palustrine forested (PFO) wetlands were identified within the property during the wetland delineation by MSA. Approximately 0.63 acres of isolated wetlands are proposed to be removed with this development.
